# Comments on the collision between a tanker and a U.S. Navy ship in the Strait of Singapore

*August 2017 (chronologically from bottom to top)*

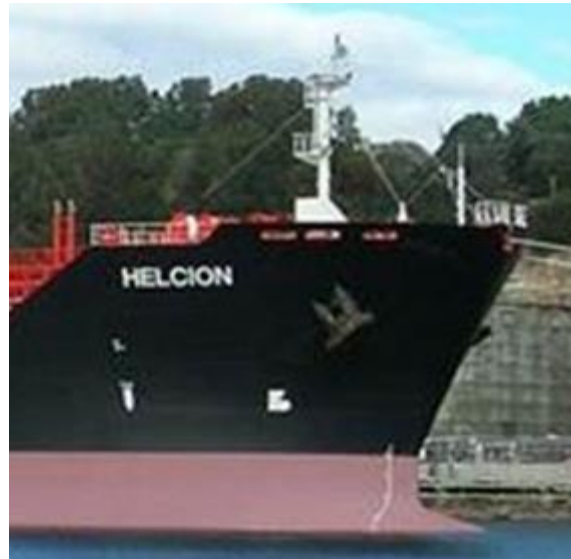
### Tanker's fore mast

Turning all deck lights on should not affect the visibility of the two vertical red lights, which need to be installed “*where they can best be seen*”, and in all the cases I know of at a height similar to the top of the aft mast light.

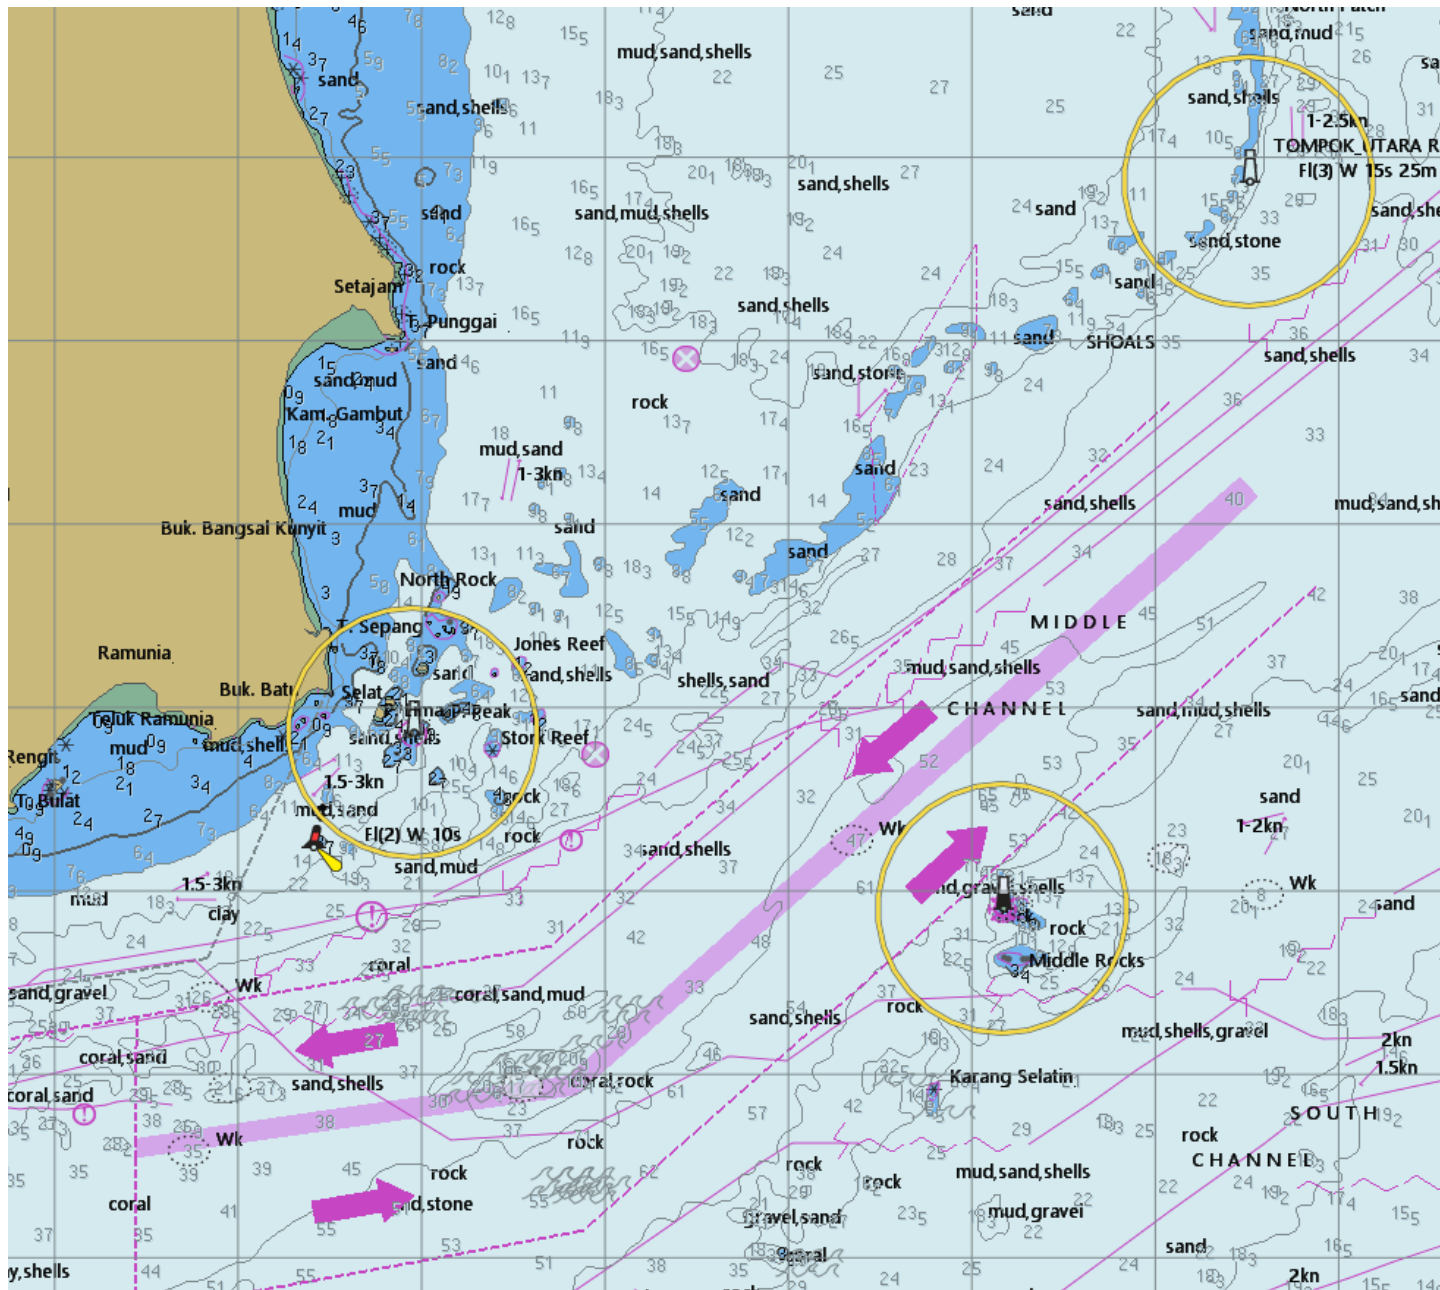
The collision seems to have happened just south of the Tompok Utara light

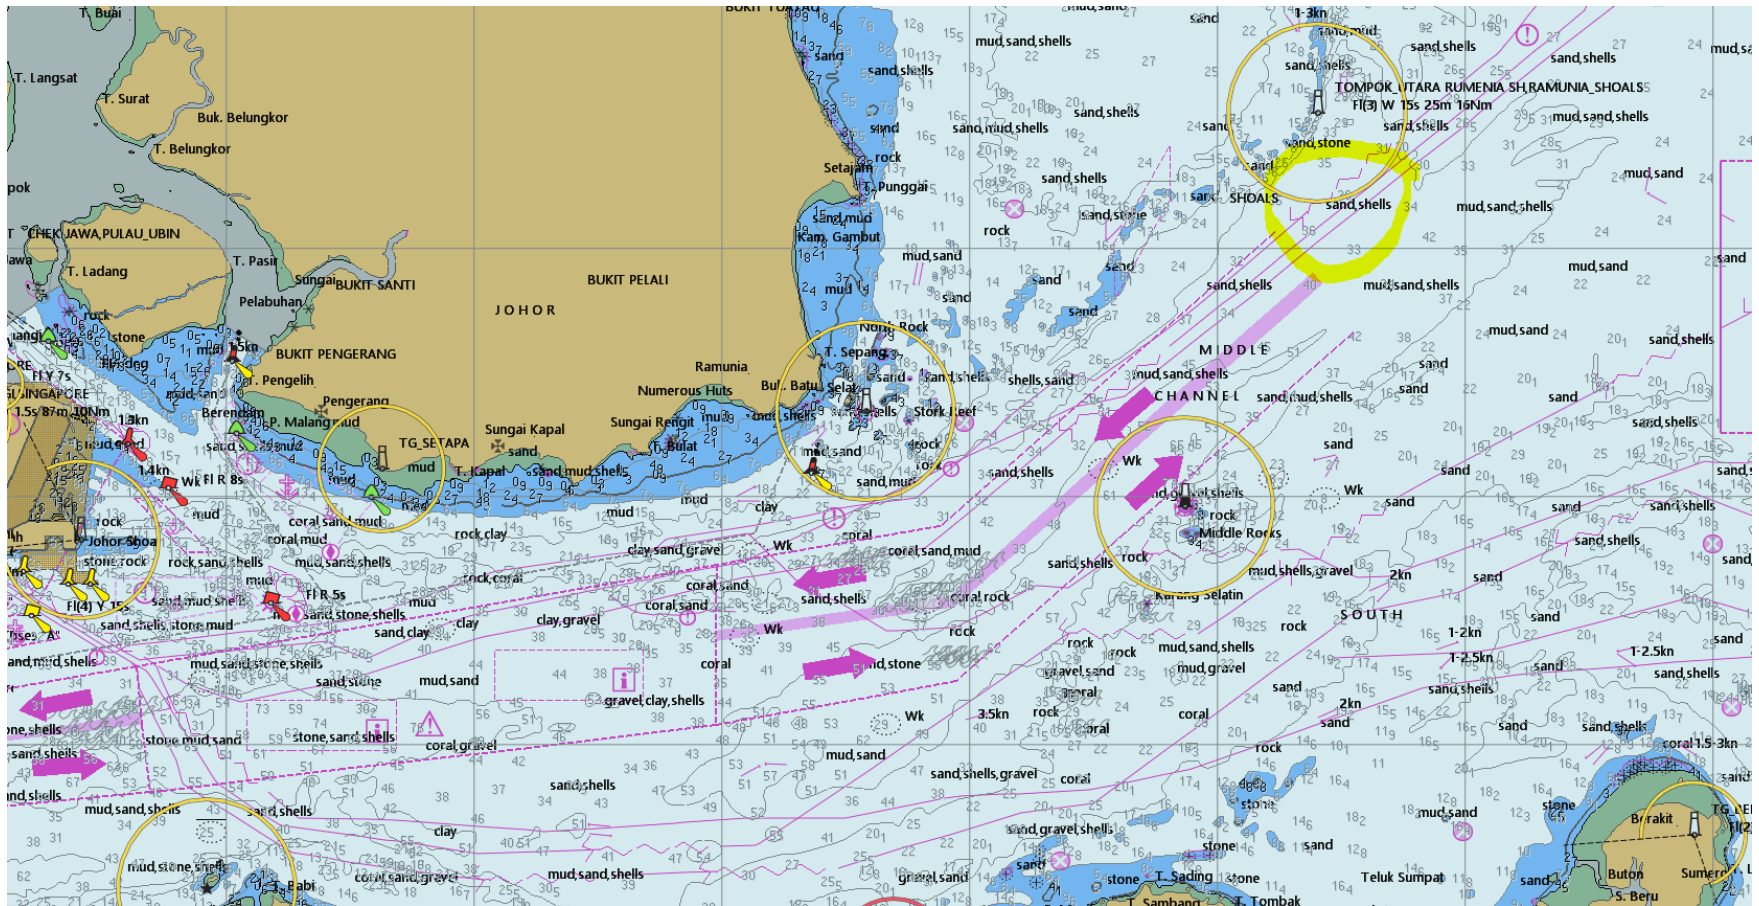
**Chart of the collision area (highlighted in yellow). If the Navy ship was heading towards Singapore, it must have been entering the SW bound channel. The tanker appears to have also been sailing to Singapore, coming from Taiwan**

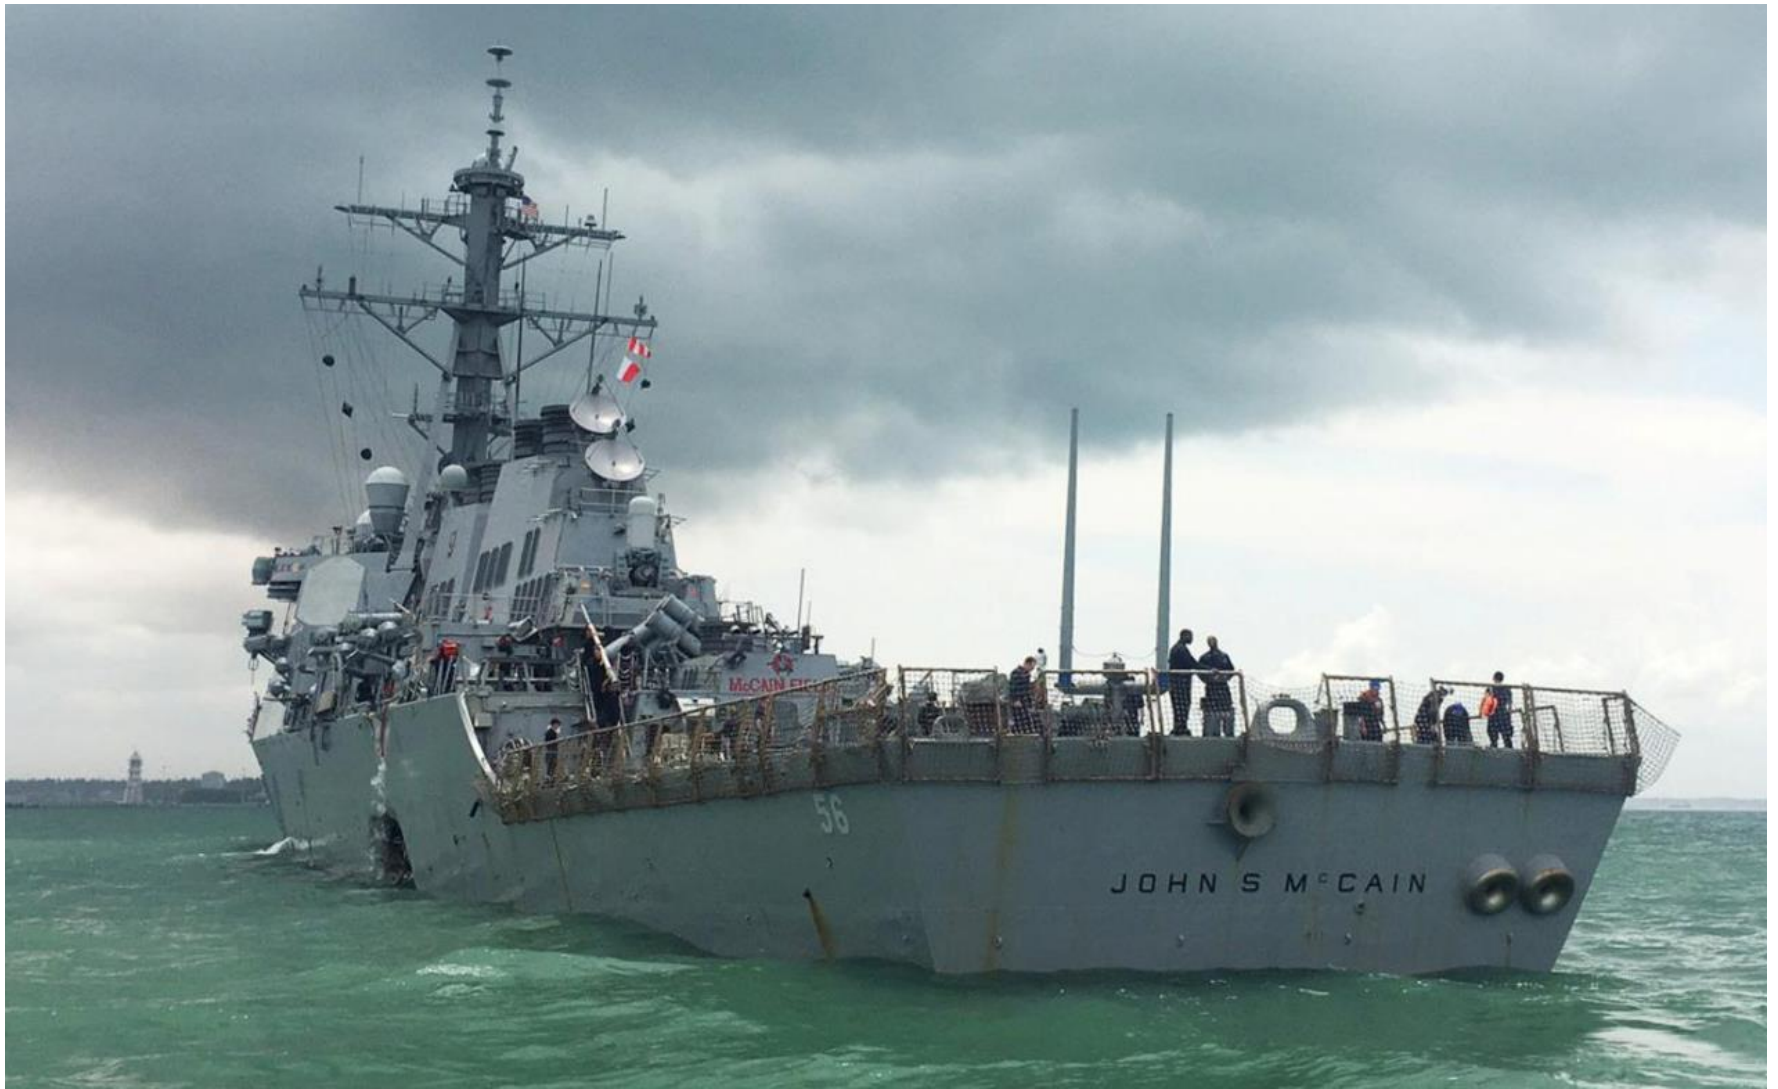
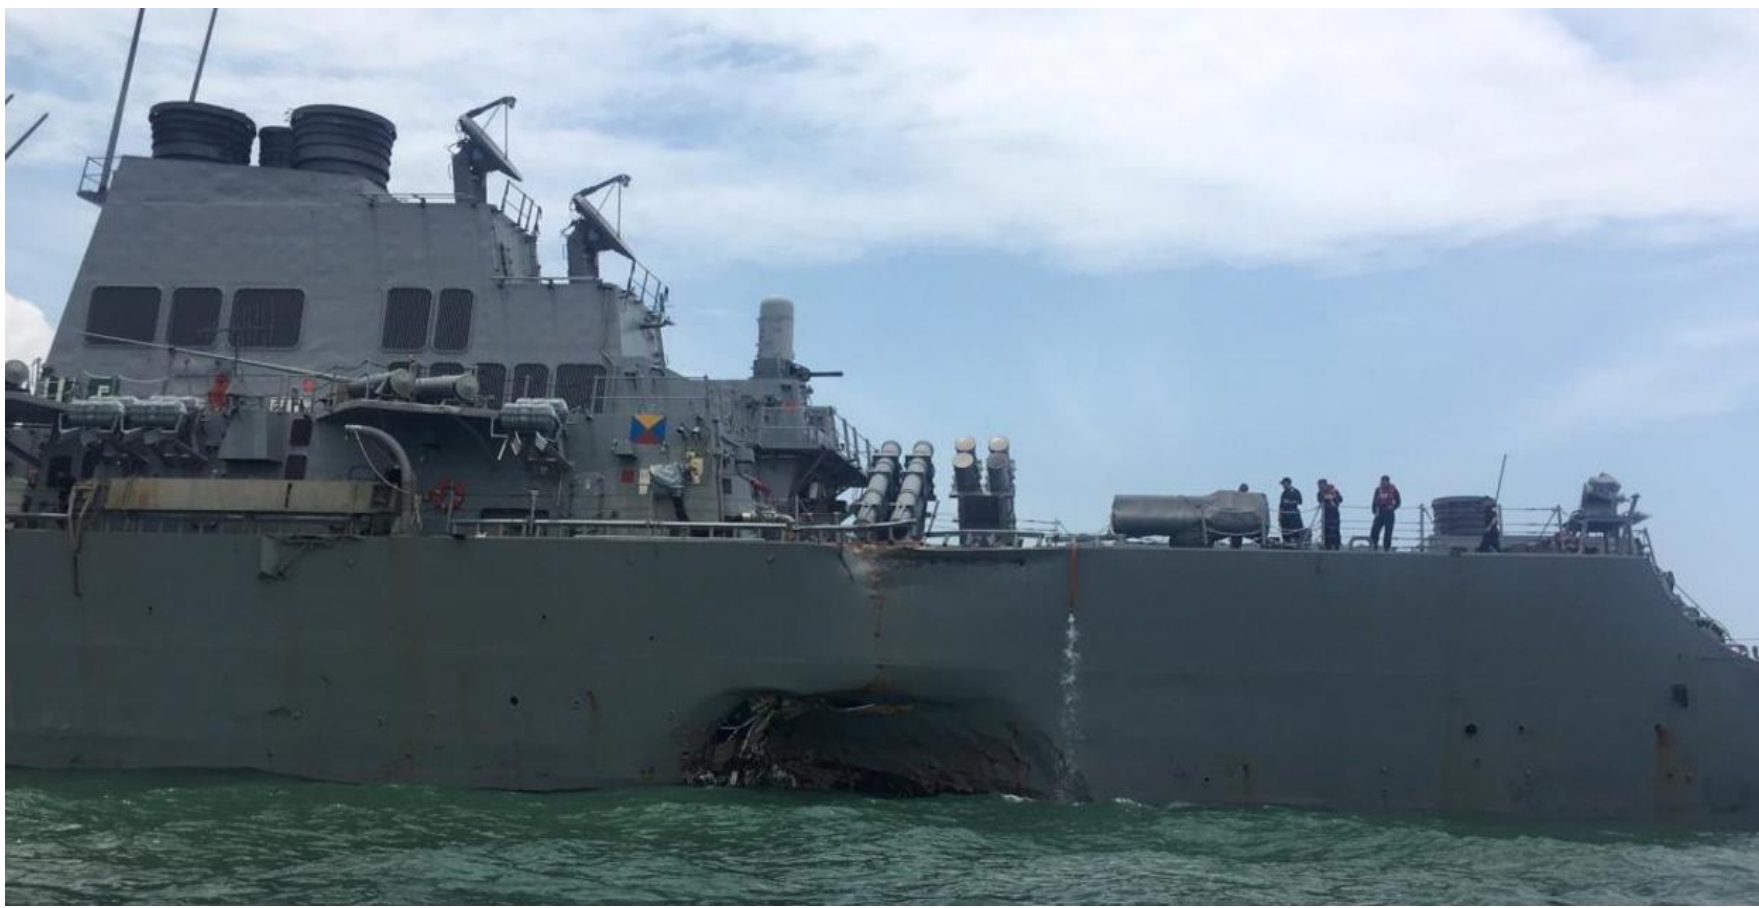
It is reported that the tanker was carrying 12,000 tons of fuel, about a quarter of her capacity, and was therefore probably quite high on the water, with her bulbous bow well above the waterline. The breach on the aft portside of the Navy ship appears to be very possibly the result of having been rammed by the tanker's bulbous bow at an angle of seemingly 30 degrees aft the port beam. See below what seems to be the imprint of the tanker's stem above the breach. Despite some press reports, the situation is quite different from the Korea collision. From the damage, it seems the Navy ship was going at very limited speed and was overtaken by the tanker, and certainly was on the tanker's starboard side. Short of a last minute steering gear malfunction, or a Navy ship helmsman's error, and contrary to the Korea incident, it seems this time the tanker would be at fault.

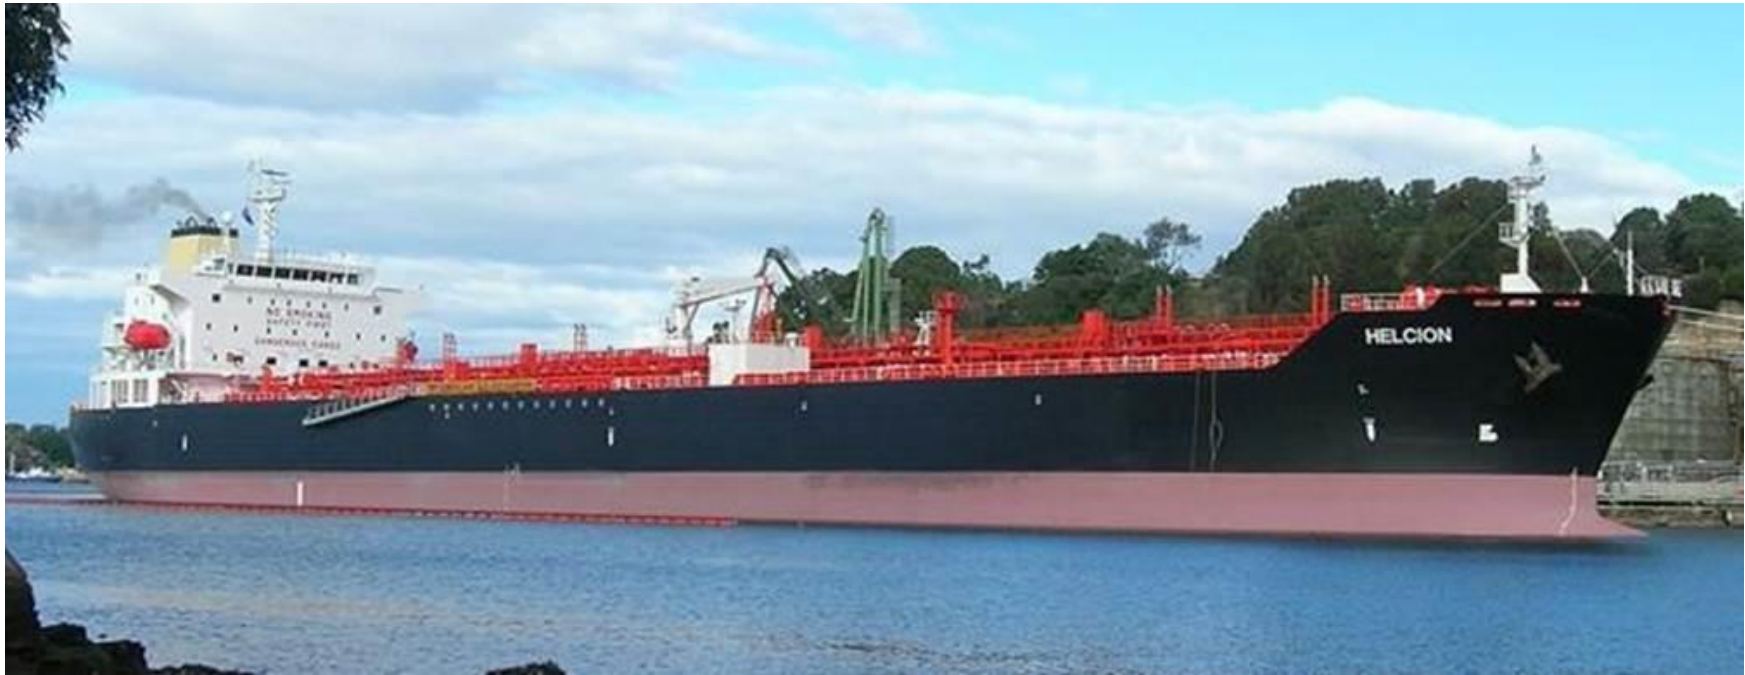
Alnic MC at light displacement, older name. See bulbous bow and stem:
